Forum on Moisture Problems in HUD Code homes in hot, humid climates

Case Study

Just a little north of New Orleans

By Neil Moyer-Principal Research Engineer

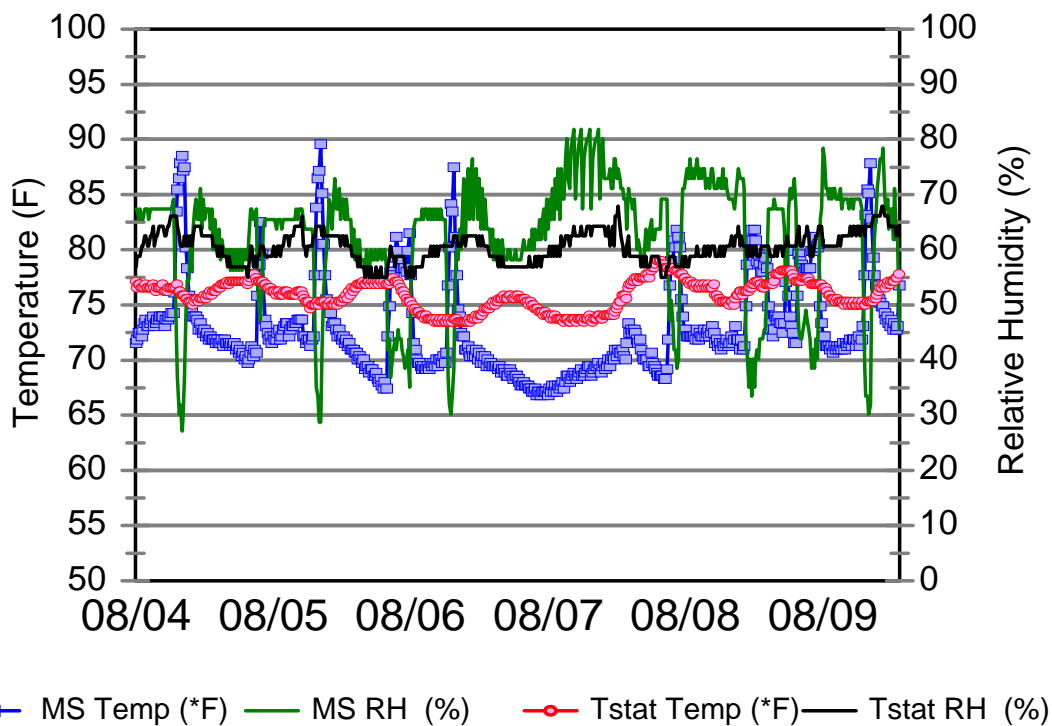
A couple of sets of Onset Computer Stowaway temperature and relative humidity dataloggers were set to the residence to be placed by the homeowner. They were asked to locate one on top of the thermostat and the other in the general location of the worst moisture problem. The master bath was selected by the homeowner and placed the sensors on top of the wall light fixture. (The operation of the bathroom lights affected the temperature and relative humidity readings. This explains the temperature peaks and relative humidity valleys that are noticed in the data.)

The master bedroom suite appears to be overcooling. This is most probably the result of at least three factors...

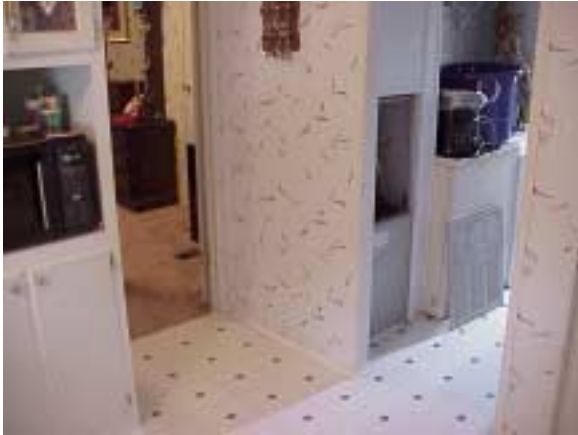
1. The master bedroom suite is located on the east end of the home and is located under a rather large shade tree.
2. The supply register in the master bedroom is very close to the air handler unit. This supply receives more than its design flow – balancing of these systems is not done.

View of AHU and ms floor register

- The air balance of the duct system should be checked. This should be done with all of the interior doors closed. The balance will probably include adjustment of supply air to the master bedroom and the addition of a return air grill through the wall directly to the return air plenum of the air handler unit. Also, the end bedroom should have an additional supply vent directly connected to the main trunk line. The pressure differentials across the various closed bedroom doors should be

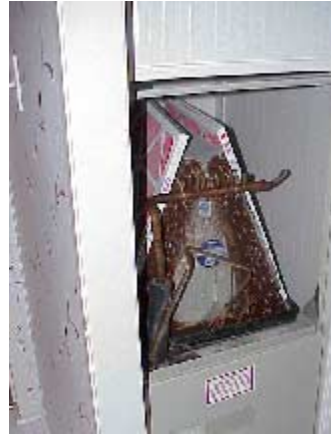
The air conditioner system is a 4-ton unit with a 4-½ ton evaporator coil. The general condition of filters and coils appeared to be good. The condensate drain pipe from the air handler unit ends in the crawlspace below the air handler unit. It dumps the water onto the ground, creating a puddle of water.

AC coil with filters

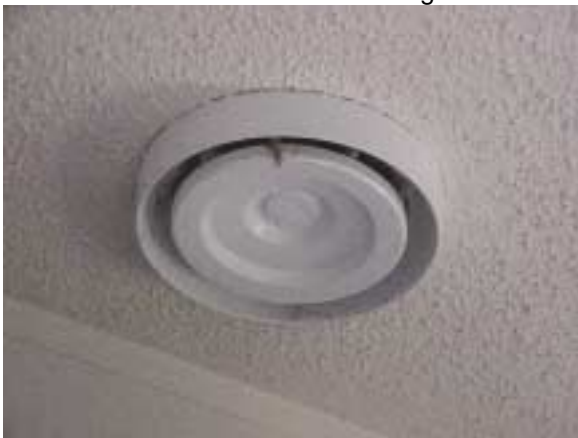
Ventilation fan (utility room and msbath)

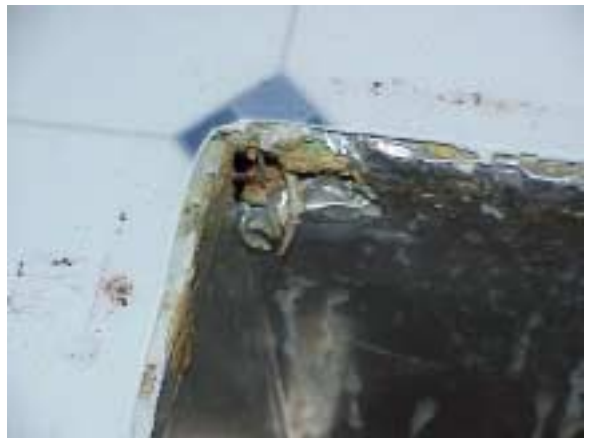
An inspection of the ductwork was done by removing a number of the supply registers and checking the connection of the riser to the main trunk line. All connections leaked; in some cases, the hole was large enough that a fist could easily pass through. This leakage would tend to pressurize the belly pan area, unless the air/vapor barrier is compromised. In that case, the leakage would be to crawlspace – and tend to depressurize the house.

- The supply side duct leakage is very significant. The operation of the air handler fan causes the house to operate in a negative pressure. This is because the supply leaks dump the air into the belly pan area that is open to the crawlspace (because of the damaged air/vapor barrier near the electric service entrance).

Small duct leak at duct riser (kitchen)

- All supply duct system leaks should be air sealed with a mastic (such as RCD#6 or equivalent). The seal must be applied to the air barrier of the ductboard (the reinforced foil backing). The areas to be sealed include all of the supply duct risers connections to the main trunk line and the connection of the air handler unit to the main trunk line (this was not checked at the time of my inspection – but should be carefully considered in the retrofit).

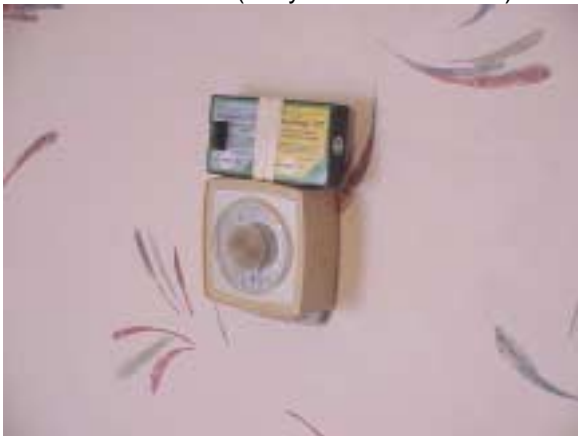
The thermostat temperature and relative humidity readings appear to be fairly normal, about 75-77 degF and a relative humidity ranging between 55 and 65 percent.

Temperature / RH datalogger @ thermostat

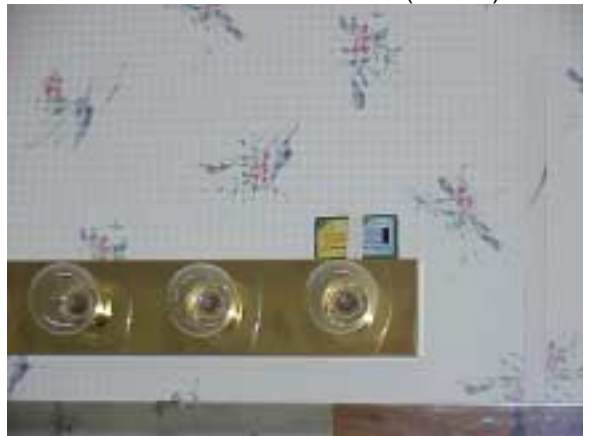
Temperature / RH datalogger in master bath

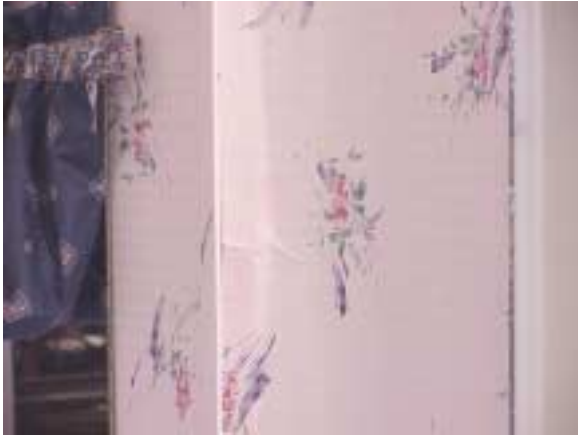
The master bathroom wallboard between the mirror and the bathtub shows evidence of severe moisture absorption. A number of other exterior wall locations also showed signs of moisture absorption as was noted when a slight pressure was applied (the wallboard did not feel solid). The only interior wall that showed any signs was in the utility room near the electrical service panel. There were no obvious signs of mold or mildew growth.

Overcooling of the master bedroom results in an interior condition temperature lower than the outside dewpoint. The average dewpoint temperatures for this area during the summer months is usually in the low 70 degree range (ASHRAE 90-2 1993 Table 6-3)

- The use of vinyl-covered wallboard on an exterior wall in the hot, humid south should be avoided- or used with great caution. The vinyl will act as a vapor barrier on the cold side of the wall. (The vapor barrier should be placed on the warm side.)
- The drilling of holes through the exterior plywood sheathing more than likely exacerbated the problem. The plywood was acting as a vapor retarder; with the addition of holes at the top and bottom of the stud wall, exterior water vapor would have an easier path to the vinyl covered wallboard.
- The use of tapes as a primary means of sealing will generally lead to failure. This is the case of the electrically service penetration under the utility room.

Master bath wall damage

- All damage wall panels should be removed and replaced. The replacement panels should be finished with a vapor permeable material to allow moisture movement to the inside. The ideal location for a vapor retarder is on the warm side of the wall. In the hot, humid climate, the warm side is the exterior (ASHRAE Fundamentals 1989, Chapter 21). The exterior plywood sheathing will act as a vapor retarder in this case. Every material located to the inside of the plywood should be at least ten times more permeable to allow for drying to the inside.
- The holes that were drilled into the plywood sheathing should be sealed or closed. The sealing could be done with the same mastic (RCD #6 or equivalent) used to seal the ductwork.
