Building America Case Study Technology Solutions for Existing Homes

Wind Washing in Two-Story Homes: Identifying the Problem and the Opportunity for Repair

Project Name: Opportunities for Energy Conservation and Improved Comfort from Wind Washing Retrofits in Two-Story Homes

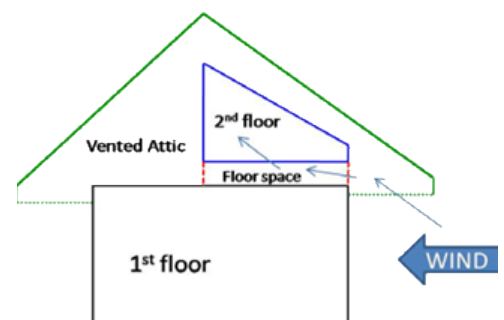
Figure 1 illustrates wind washing caused by air movement into the soffit, then into the attic, and finally into the floor space. Wind-driven attic air is pushed into the space between floors, bypassing house air and thermal boundaries.

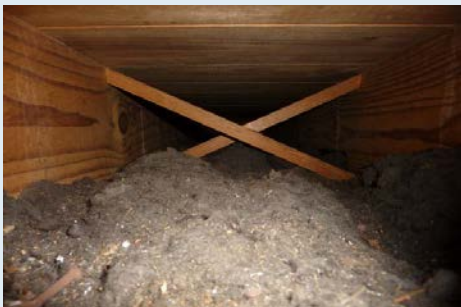
This image shows a floor cavity that is open to a vented attic on one end, and has conditioned space above and below

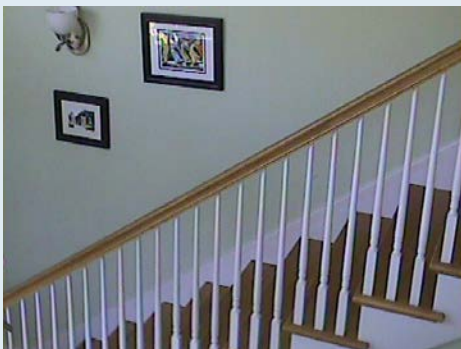
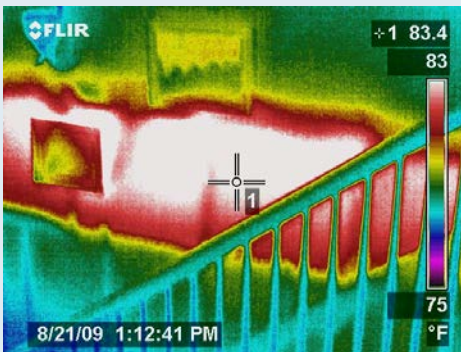
IR scans show temperature variations, and reveal the operation of the wind washing phenomenon. As shown in the above images, thermal anomalies are occurring where hot attic air has penetrated into the floor cavity that lies behind the stairwell wall. The wall surface temperature was 83°F compared to 78°F room temperature.

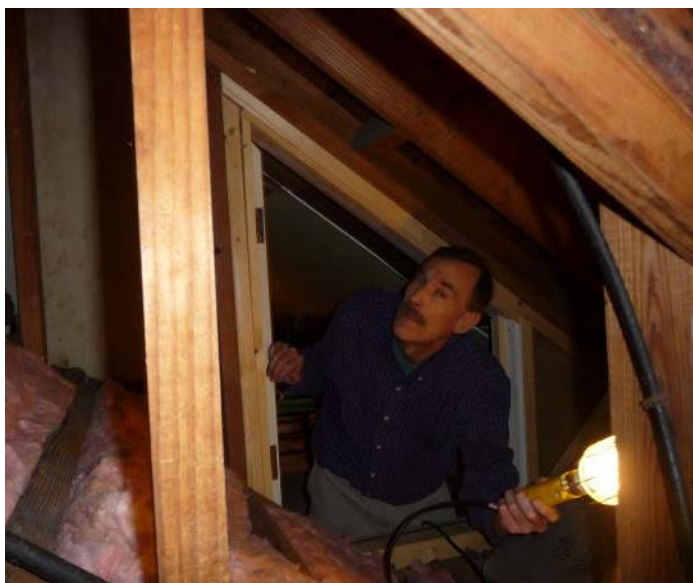
Figure 2. Field tests can be conducted to characterize the existence of wind washing, the problems it causes, repair strategies, and the potential benefit of the repair. These tests include visual inspections (see left image), infrared (IR) scans of house surfaces (see sidebar), air/thermal boundary integrity, pressure mapping, air leakage assessment, and duct leakage assessment.
